DRAFT
**GEOTECHNICAL ENGINEERING INVESTIGATION AND
GEOLOGIC/SEISMIC HAZARDS EVALUATION
PROPOSED FIRE STATION
SOUTHWEST OF THE INTERSECTION OF MORONGO & SANTIAGO ROADS
RIVERSIDE COUNTY, CALIFORNIA**

Project Number: H17401.01

Subject: Geotechnical Engineering Investigation and
Geologic/Seismic Hazards Evaluation
Proposed Fire Station
Southwest of the Intersection of Morongo Road and Santiago Road
Riverside County, California

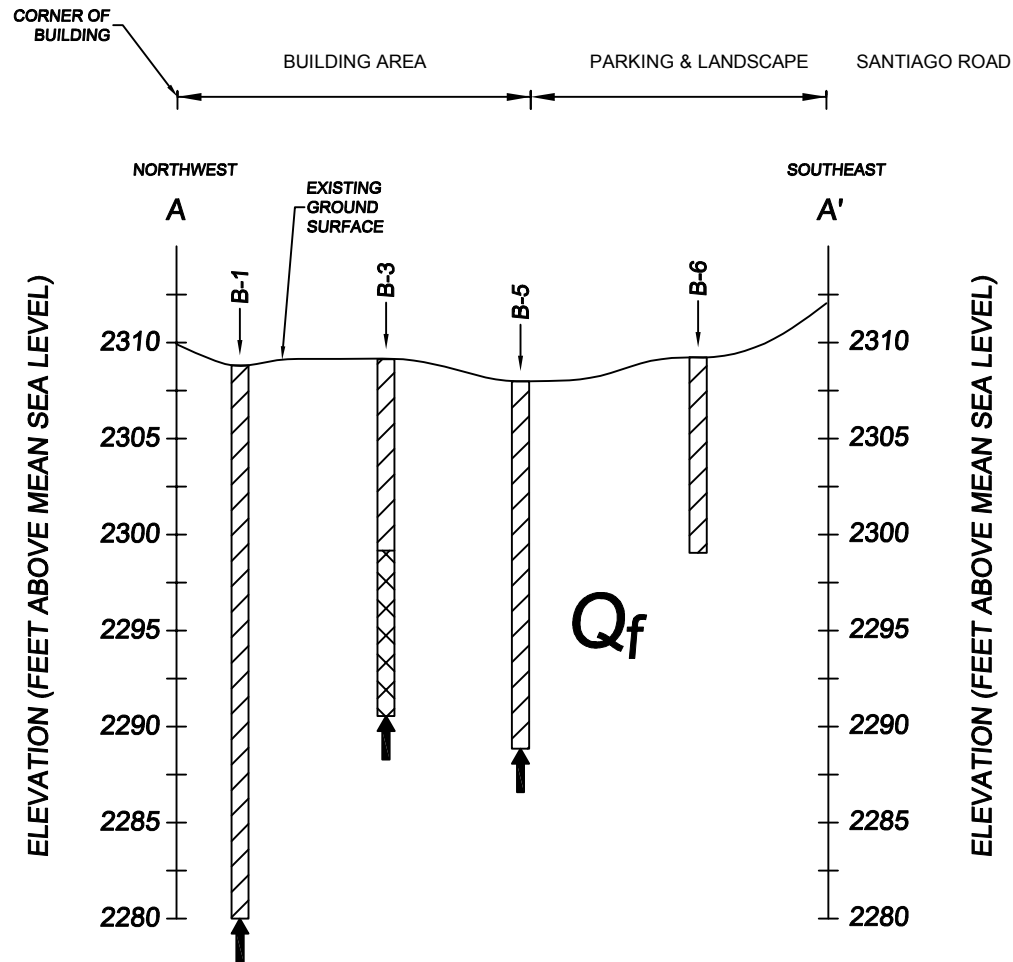
DRAWING NO.
8

GEOLOGIC UNITS

Q_f: ALLUVIAL FAN OF SAN GORGONIO PASS, SAND AND GRAVEL OF PLUTONIC AND GNEISSIC DETRITUS DERIVED FROM RISING SAN BERNARDINO MOUNTAINS TO NORTH; SLIGHTLY DISSECTED BY STREAM CHANNEL; INCLUDES SMALL ALLUVIAL FANS AT BASE OF AND DERIVED FROM SAN JACINTO MOUNTAINS IN SOUTH AREA

Drawing No. 8 - Soil Profile Cross Section A-A'
